SERVICE BULLETIN 34T-06-320-01

Models Affected: 34 Trawler – Hulls GM101 through GM197

It has come to our attention that the swim platform on the 34 Trawler may not be properly secured to the hull. The purpose of this bulletin is to provide proper direction on how to secure the platform to the stanchions and the hull.

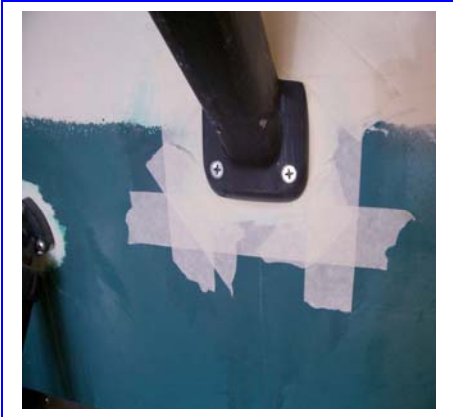
Step 1: Tape a double layer of tape around stanchion foot on transom. Be sure to cover all paint. Remove stanchion from transom and platform. Grind **only** area on transom in between tape to remove excess 5200 sealant and paint. This will ensure a better mating surface when attaching stanchions.

Note: Remove only 1 stanchion at a time.

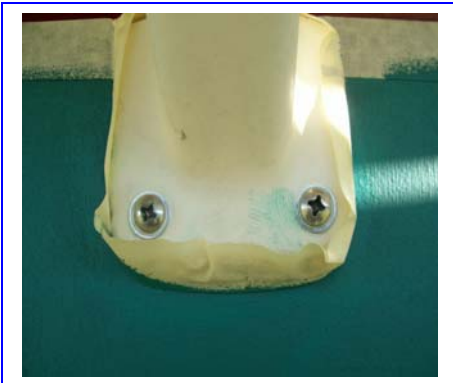
Step 2: The screw holes on the transom need to be re-drilled using a ¼ drill bit (go completely through transom and through hull pad on the inside). The screw holes on the underside of the swim platform need to be re-drilled using a 5/16- drill bit (go completely through swim platform).

Note: To avoid ripping hull pad when drilling, hold a wood block firmly in place over hull pad and drill through wood block.

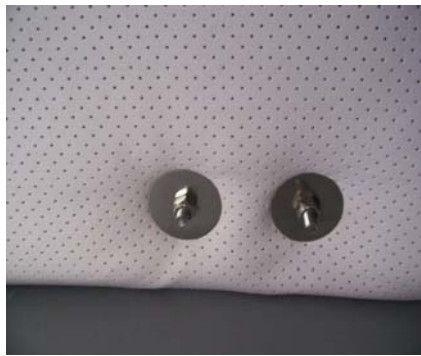
Step 3: Cover the bottom foot of the stanchion with 5200 sealant and put into place on the transom. Install using ¼ x 20 x 3 pan head screws with a ¼ flat washer.

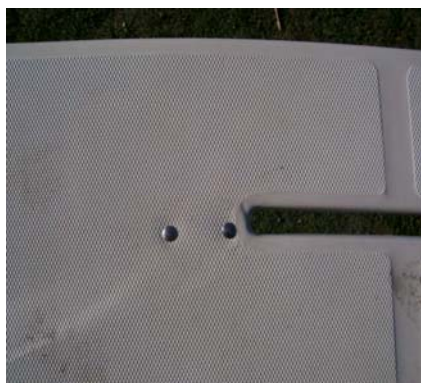
Step 4: In the aft engine compartment, tighten screws in place using a 1/4 fender washer and a 1/4 nylock nut. Clean excess sealant.

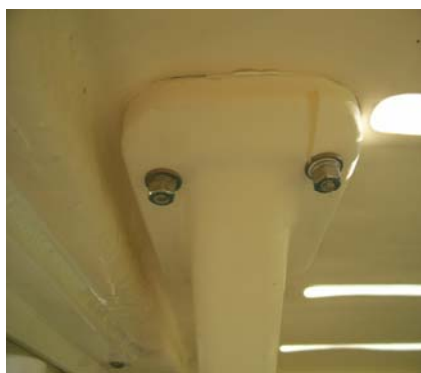
Step 5: On the top foot of the stanchion, cover with 5200 sealant. From the top, install a 5/16 x 2 1/2 carriage bolt.

Step 6: Tighten carriage bolts in place using a 5/16 flat washer and a 5/16-nylock nut. Break off remaining screw and clean excess sealant
